DEPARTMENT OF TRANSPORTATION

Quality Assurance and Source Inspection

Contract #: 04-0120F4Cty: SF/ALA Rte: 80 PM: 13.2/13.9File #: 69.28**WELDING INSPECTION REPORT****Resident Engineer:**Pursell, Gary**Address:** 333 Burma Road**City:** Oakland, CA 94607**Report No:** WIR-013627**Date Inspected:** 22-Apr-2010**Project Name:** SAS Superstructure**OSM Arrival Time:** 700**Prime Contractor:** American Bridge/Fluor Enterprises, a JV**OSM Departure Time:** 1900**Contractor:** Zhenhua Port Machinery Company, Ltd (ZPMC), Changxing Island **Location:** Shanghai, China**CWI Name:** Li Yang**CWI Present:** Yes No**Inspected CWI report:** Yes No N/A**Rod Oven in Use:** Yes No N/A**Electrode to specification:** Yes No N/A**Weld Procedures Followed:** Yes No N/A**Qualified Welders:** Yes No N/A**Verified Joint Fit-up:** Yes No N/A**Approved Drawings:** Yes No N/A**Approved WPS:** Yes No N/A**Delayed / Cancelled:** Yes No N/A**Bridge No:** 34-0006**Component:** OBG**Summary of Items Observed:**

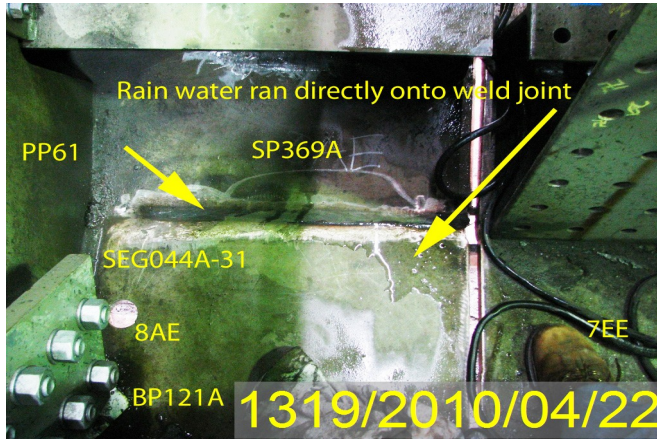
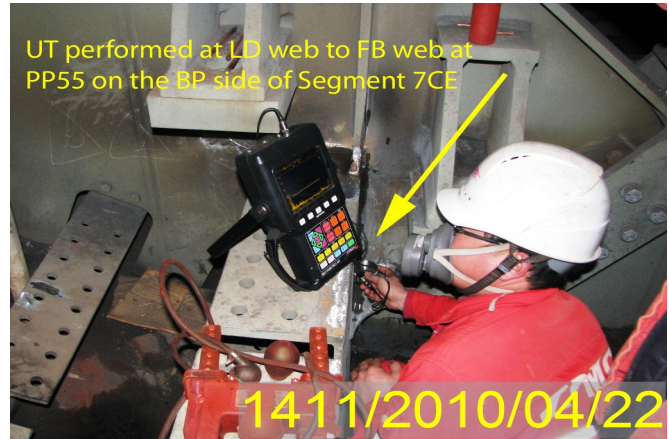
This QA Inspector observed welding being performed on side plate to deck plate hold back weld (SEG044A-31) located at bike path side of segment. This QA noted upon completion of noted weld joint, this QA Inspector observed rain water ran directly over weldment. This QA Inspector issued an incident report for today's work shift.
